Machinery Messages

Case History

Using Data Manager® 2000 to remotely diagnose gas compressor rotating stall

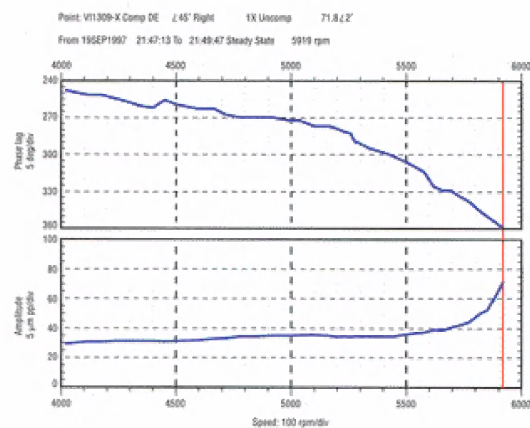
vibration recorded during the start-up, moments before the trip (Figures 2 and 3), show that, during the load increase on compressor B, vibration levels had increased significantly, along with a phase change of approximately 90°.

Figure 2. Bode plot of 1X amplitude and phase during startup.

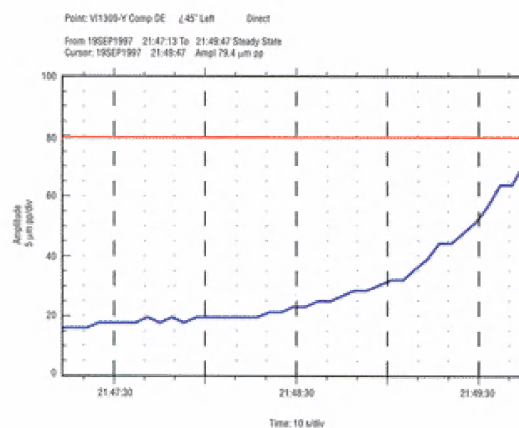
Figure 3. Trend plot of direct vibration amplitude during startup.

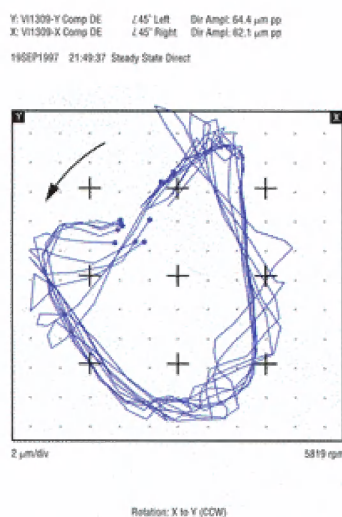
A closer inspection of the vibration data taken during the runup showed that, as the 1X vibration amplitude increased, the shape of the orbit changed into an abnormal,

almost square, form. The orbit plot represents the movement of the shaft centerline (if the shaft relative proximity transducer is not moving). One explanation for these square orbits is that the vibration probes were moving as well. MMS, therefore, advised the operator to inspect the casing foundation bolts. These bolts were loose! The manufacturer was called to inspect the unit, as it was still under warranty.

Figure 4. Changing shaft orbit pattern at compressor drive end.

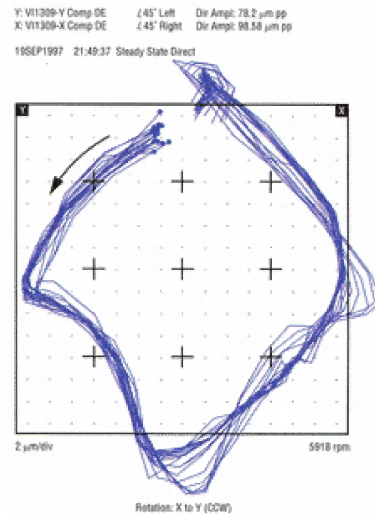
Figure 5. "Square" shaft orbit at compressor drive end just before the trip.

After the OEM had properly realigned the compressor and cor-

rectly tightened the foundation bolts, the unit was ready for a restart. This time, Bently Nevada MMS Engineers were online via modem during the startup. The unit ran up to nearly 7000 rpm without any problems. At 7200 rpm, though, the unit suddenly experienced high vibration amplitude again. Within 2½ minutes, as the speed continued to increase, the vibration amplitude increased from 10 to 110 mm pp, and the unit tripped. At first, operations suspected that the compressor's problem hadn't been solved.

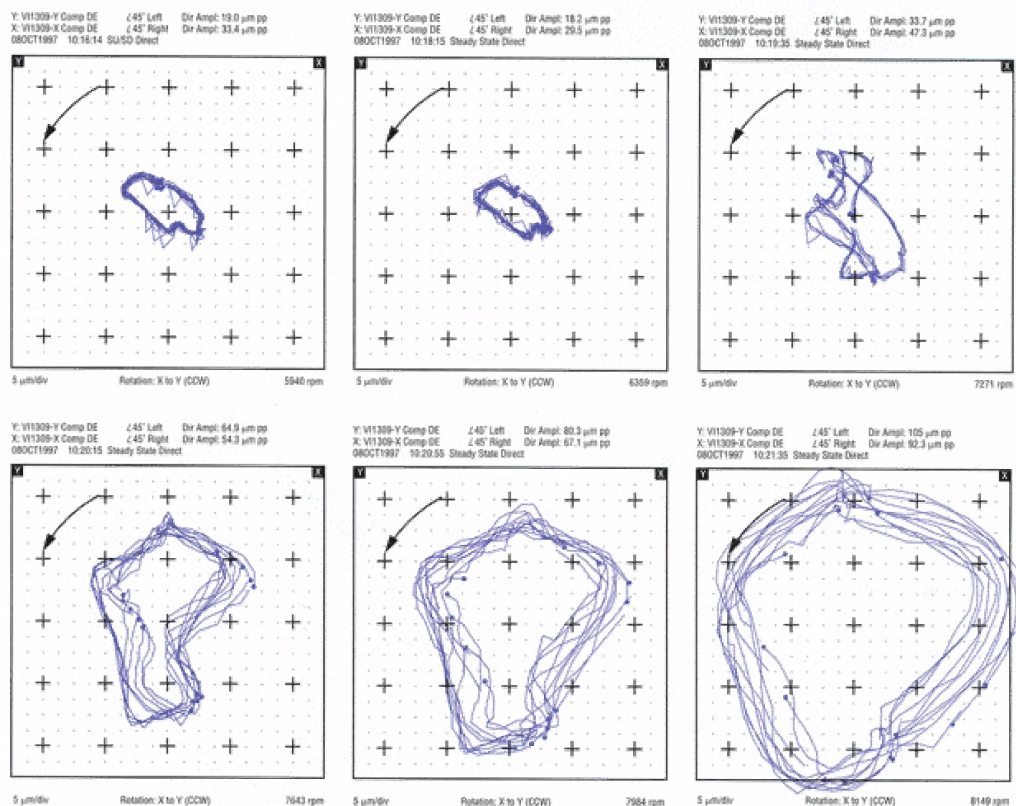
However, machinery data from the DM2000 system showed that the orbit shape and Keyphasor® dot pattern (Figure 6) differed substantially from the earlier orbit, and the machine clearly had a different problem.

The vibration data up to 7000 rpm showed a normal 1X amplitude and phase behavior. After that, the machine's vibration response became unstable, and a subsynchronous vibration component dominated the orbit.

Figure 6. The orbit patterns during the startup of the compressor. At 7271 rpm the orbit shape is dominated by a subsynchronous vibration component, caused by circumferentially propagating pressure waves in the impeller.

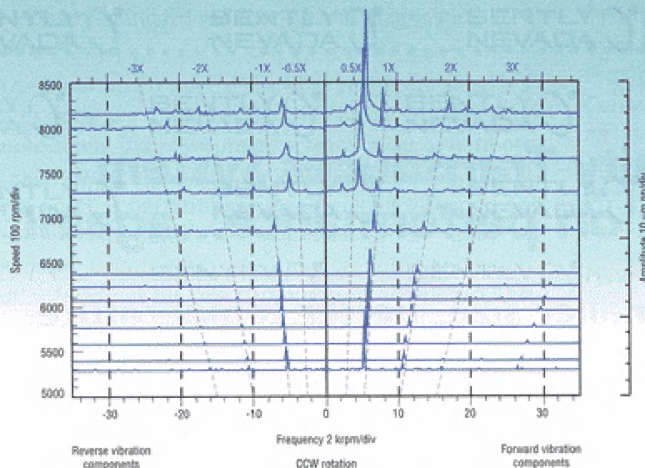
The vibration full spectrum cascade plot (Figure 7) shows that this

subsynchronous component is forward and at approximately 0.65X running speed.

Figure 7. The full spectrum cascade plot clearly indicates that the subsynchronous vibration is tracking running speed at 0.65X and is forward in precession.

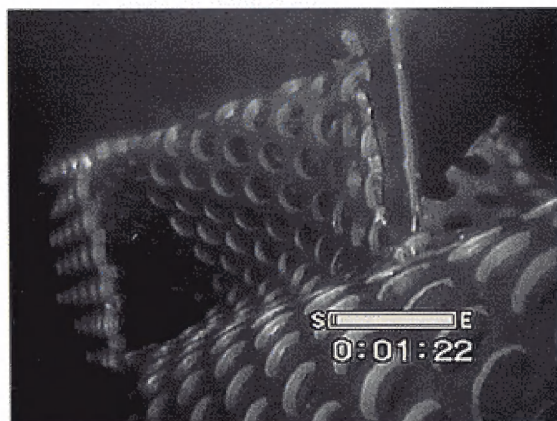
After opening the compressor inlet strainers, it was seen that large parts of these filters were ripped off and missing. It was concluded that these parts had been sucked into the compressor, so a borescope investigation was performed. As soon as the camera entered the compressor inlet, a large piece of the filter was visible, folded around an inlet guide

vane (Figure 8). This piece of filter, which clearly blocked a large part of the compressor inlet, was the reason for the rotating stall at the impeller. Although the compressor inlet and outlet pressure and flow conditions indicated that the unit was far from a surge condition, the filter part affected the inlet flow to such an extent that the operating point in the impeller moved close to the surge limit, and boundary layer separation took place. This caused the characteristic high amplitude, subsynchronous vibration.

Figure 8. A borescope picture of the compressor inlet eye shows a large piece of the inlet strainer folded around the inlet guide vanes and blocking the compressor inlet eye.

Further inspections revealed that all the inlet filters of Units A and B had also partially or completely disintegrated. To prevent further damage, the operator decided to remove these filters.
